**DEPARTMENT OF TRANSPORTATION**

Contract #: 04-0120F4Cty: SF/ALA Rte: 80 PM: 13.2/13.9File #: 69.28**WELDING INSPECTION REPORT****Resident Engineer:** Pursell, Gary**Address:** 333 Burma Road**City:** Oakland, CA 94607**Report No:** WIR-016494**Date Inspected:** 16-Aug-2010**Project Name:** SAS Superstructure**OSM Arrival Time:** 700**Prime Contractor:** American Bridge/Fluor Enterprises, a JV**OSM Departure Time:** 1900**Contractor:** Zhenhua Port Machinery Company, Ltd (ZPMC), Changxing Island **Location:** Shanghai, China**CWI Name:** Qiu Wen**CWI Present:** Yes No**Inspected CWI report:** Yes No N/A**Rod Oven in Use:** Yes No N/A**Electrode to specification:** Yes No N/A**Weld Procedures Followed:** Yes No N/A**Qualified Welders:** Yes No N/A**Verified Joint Fit-up:** Yes No N/A**Approved Drawings:** Yes No N/A**Approved WPS:** Yes No N/A**Delayed / Cancelled:** Yes No N/A**Bridge No:** 34-0006**Component:** Tower & OBG Components**Summary of Items Observed:**

EXTERNAL PRE-BLAST INSPECTION OF NORTH TOWER LIFT-2 FROM 83 M TO 77 M ELEVATION

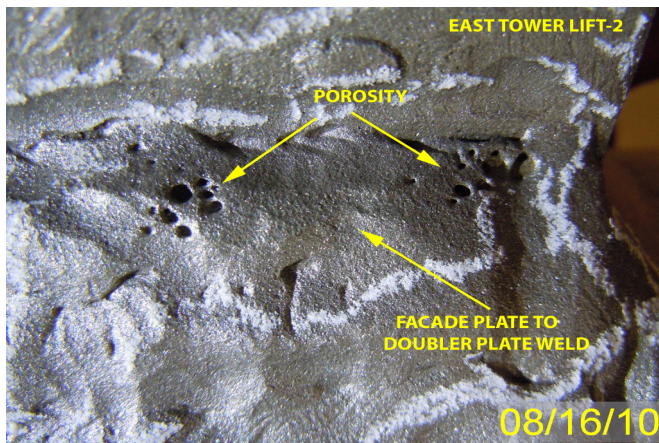
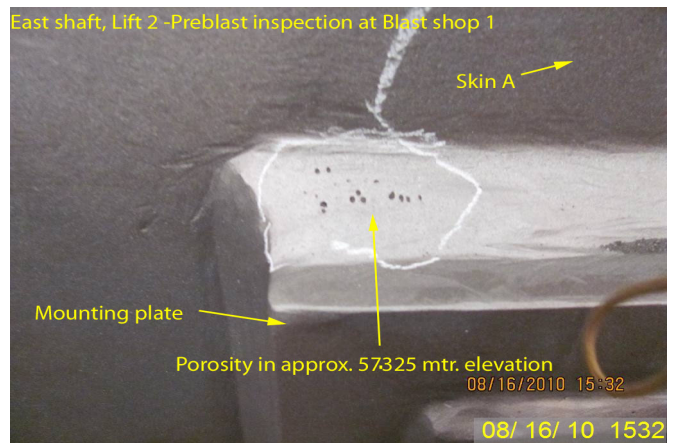
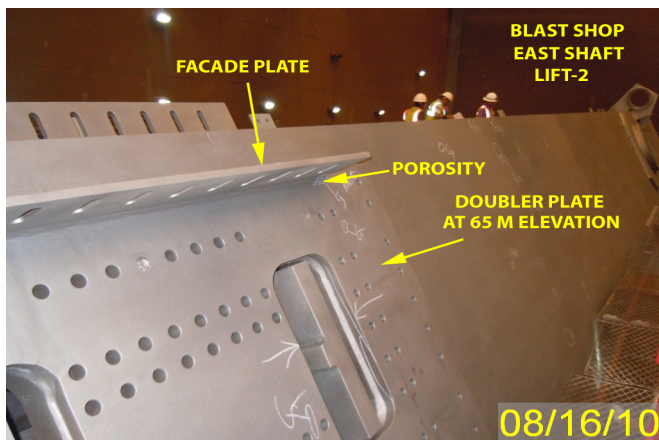
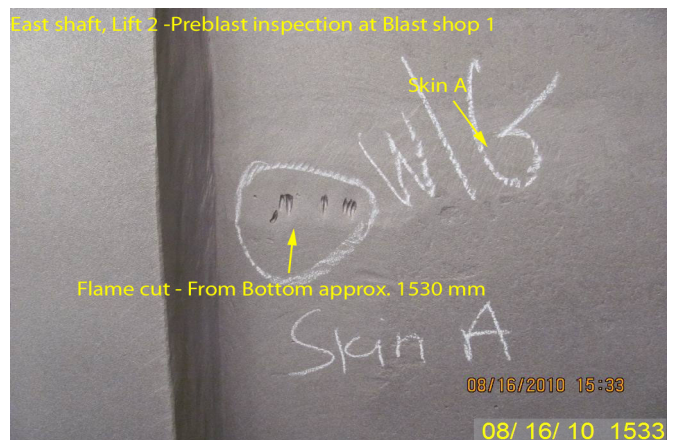
During the External pre-blast visual inspection on East tower Lift-2, this Quality Assurance Inspector (QA) discovered the defects required welding and Magnetic particle testing on weld and base material at the following locations:

- 1) Skin 'A' – Flame cut – 1530 mm from bottom and 620 mm from A/E corner.
- 2) Skin 'A' – Arc Gouge – 1535 mm from bottom and 50 mm from A/B corner.
- 3) Skin 'A' – Arc Gouge – 1535 mm from bottom and 450 mm from A/B corner.

- 4) Skin 'A' – Porosity – 2nd Mounting plate from bottom at 57.325 M elevation.
- 5) Skin 'A' – Porosity – Façade plate to doubler plate weld at 65 M elevation.

- 6) Skin 'B' – Arc Gouge – 59 meter elevation, 1000 mm from B/C corner.
- 7) Skin 'D' – Arc Strike – 65 meter elevation.
- 8) Skin 'D' – Arc Gouge – 1000 mm from bottom and 200 mm from D/E corner.

- 9) Skin 'D' – Flame cut – 64 meter elevation, 140 mm from D/E corner.
- 10) Skin 'E' – Arc Gouge – 150mm from bottom and 100 mm from D/E corner.
- 11) Skin 'E' – Arc Gouge – 56 meter elevation, 430 mm from D/E corner.

- 12) Skin 'E' – Flame cut – 64 meter elevation, 95 mm from D/E corner.
- 13) Skin 'E' – Arc Gouge – 55 meter elevation, 100 mm from A/E corner.

For further information, please see the attached pictures below.
